## **APPENDIX V: DPR FORMS – DISTRICT RECORDS**

Page 1 of 27      \*Resource Name or #: (Assigned by recorder) Crescent Heights Study Area

Crescent Heights Boulevard was surveyed as part of the 2022-2023 multi-family survey update. The block between Norton Avenue and Fountain Avenue (study area) was identified for evaluation as a potential historic district through public comment. See attached District Record.

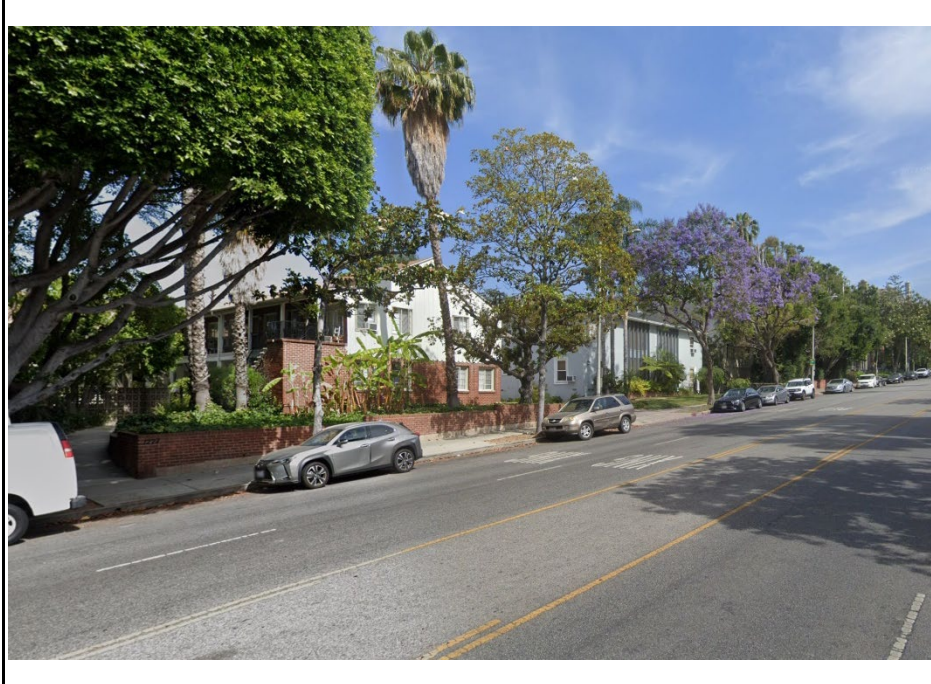
**P5a. Photograph or Drawing** (Photograph required for buildings, structures, and objects.)

**P5b. Description of Photo:** (view, date, accession #) View facing NW, Google

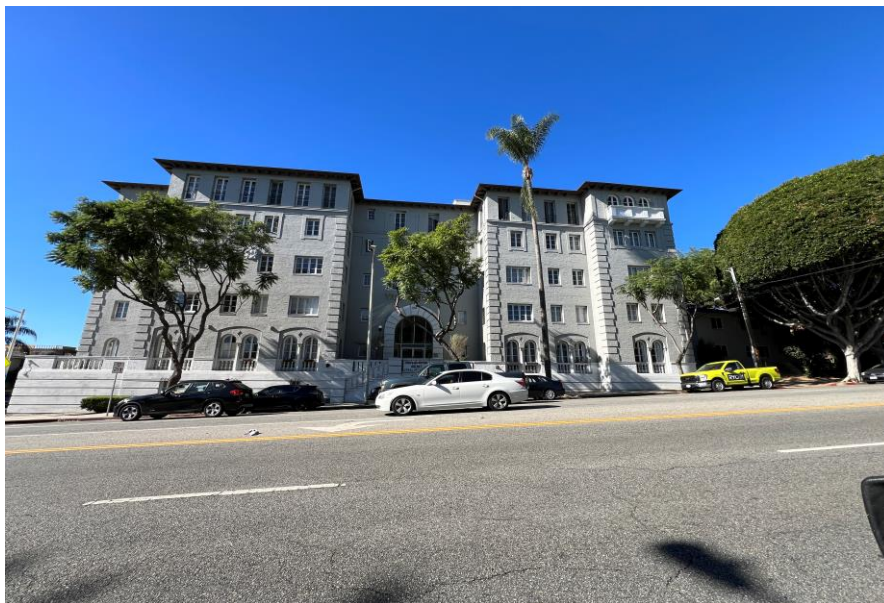
P5a. Photograph or Drawing: (Photograph required for buildings, structures, and objects.)

(View, date, accession #)  
View facing east, November 2023.

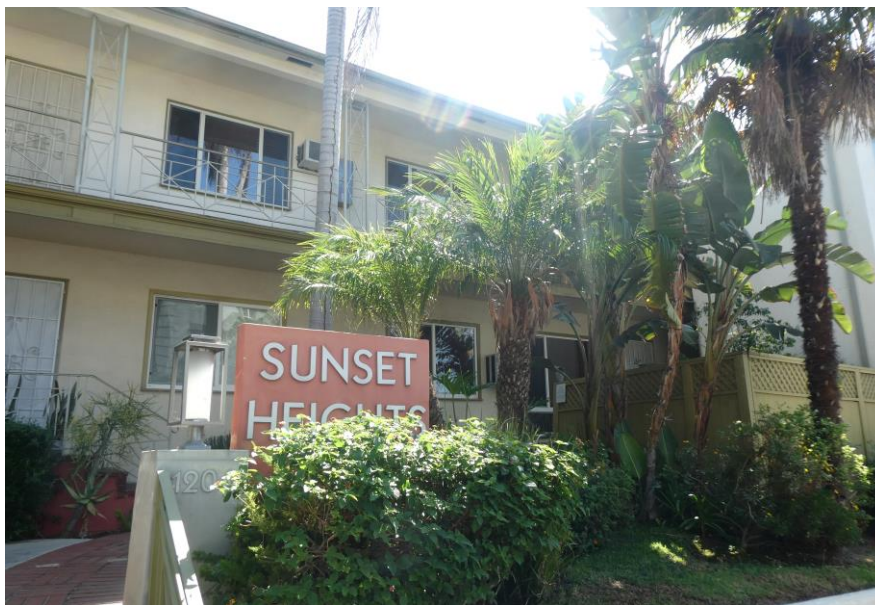
**P5a. Photograph or Drawing:** (Photograph required for buildings, structures, and objects.)

(View, date, accession #)  
View facing east. September 2022.

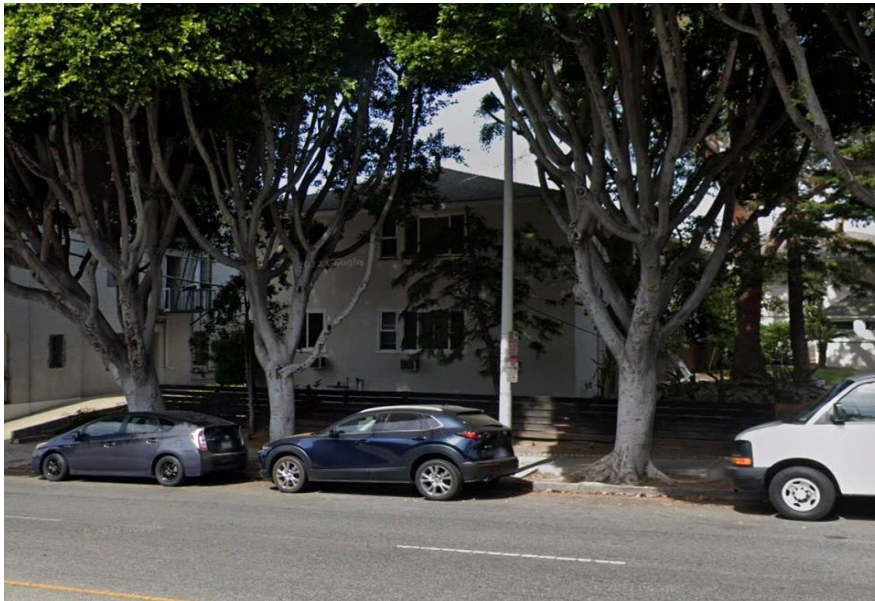
**P5a. Photograph or Drawing:** (Photograph required for buildings, structures, and objects.)

(View, date, accession #)  
View facing west (Google).

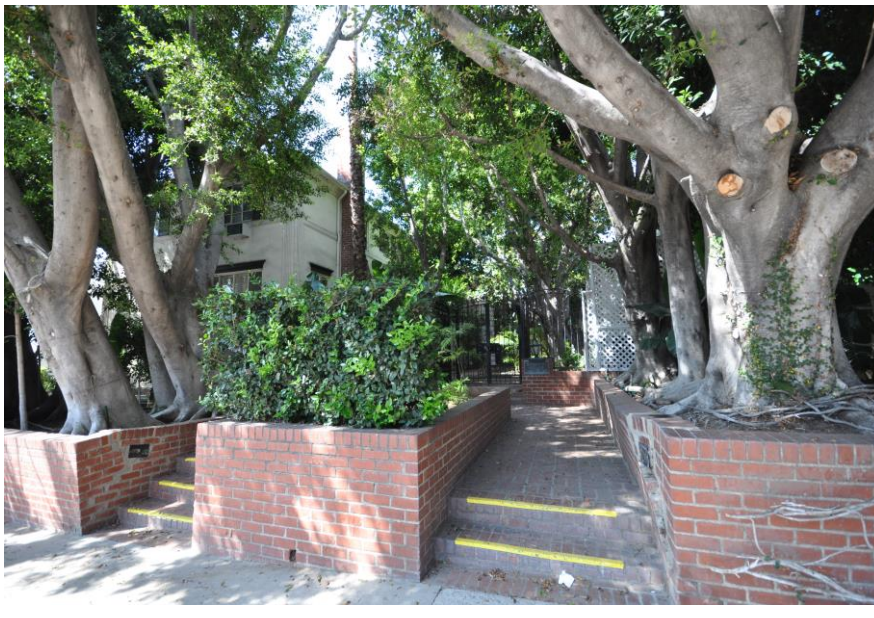
P5a. Photograph or Drawing: (Photograph required for buildings, structures, and objects.)

(View, date, accession #)  
View facing southwest. September 2022.

Constructed, 1949. Replace wood deck and privacy screen, 2022.

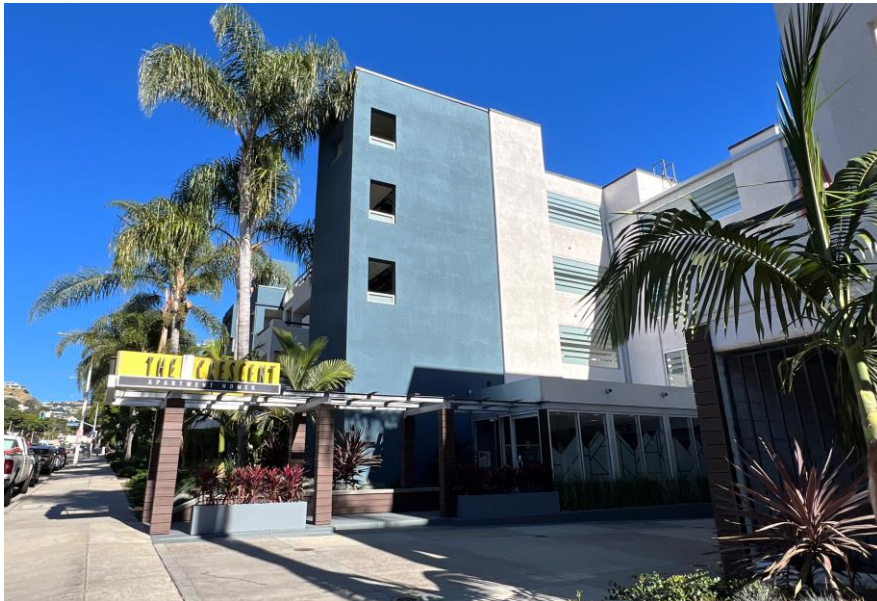
This is a 3-story Postwar Apartment House (Type B) built in 1985. The building is roughly T-shaped in plan. Exterior walls are stucco. The building has a flat roof with parapet. Windows consist of aluminum sliding windows. Individual unit entrances appear to be accessed from interior courtyards and exterior walkways. There is a main entrance on the west elevation of the property that consists of a fully glazed metal door underneath a flat canopy with signage reading "THE CRESCENT APARTMENT HOMES." Landscaping includes hedges, mature trees, and foundation plantings at the edges of the property. There is also an entrance to a parking garage on the west side of the property.

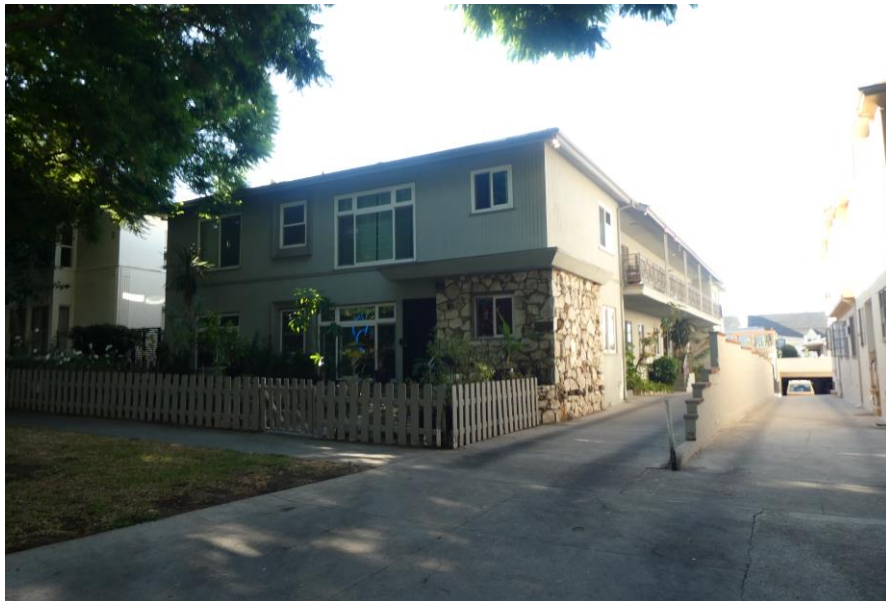
(View, date, accession #)  
View facing southeast, September 2022.

The building has a front yard area with a lawn and foundation plantings. The yard is enclosed by a low picket fence with a gate. There is a concrete walkway leading to a unit entrance on the front elevation and a concrete driveway running along the west edge of the property. There is a one-story carport and soft-story parking at the rear of the property.

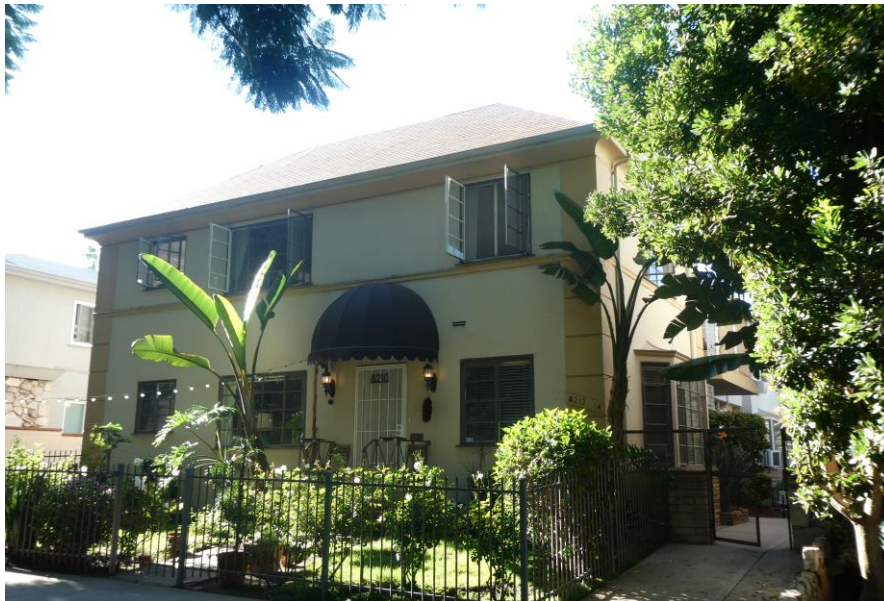
(View, date, accession #)  
View facing southeast, September 2022.

**P3a. Description:** (Describe resource and its major elements. Include design, materials, condition, alterations, size, setting, and boundaries.)  
This is a 2-story apartment house with French Revival influences built in 1950. The building is rectangular in plan. Exterior walls are stucco. Ornamentation consists of quoins and a string course. The building has a hipped roof clad in composition shingles with boxed eaves. Fenestration consists of multi-light casement windows. Individual units appear to be accessed via interior corridors. The main entrance to the building consists of a single wood-paneled door under a rounded canvas awning. The entrance is accessed by a set of shallow steps.

The building has a front yard area with a lawn and foundation plantings. The yard is enclosed by a low metal fence. There are concrete walkways leading to a unit entrance on the front elevation and along the west side of the property. There is a concrete driveway running along the east edge of the property. There is a one-story carport and soft-story parking at the rear of the property.

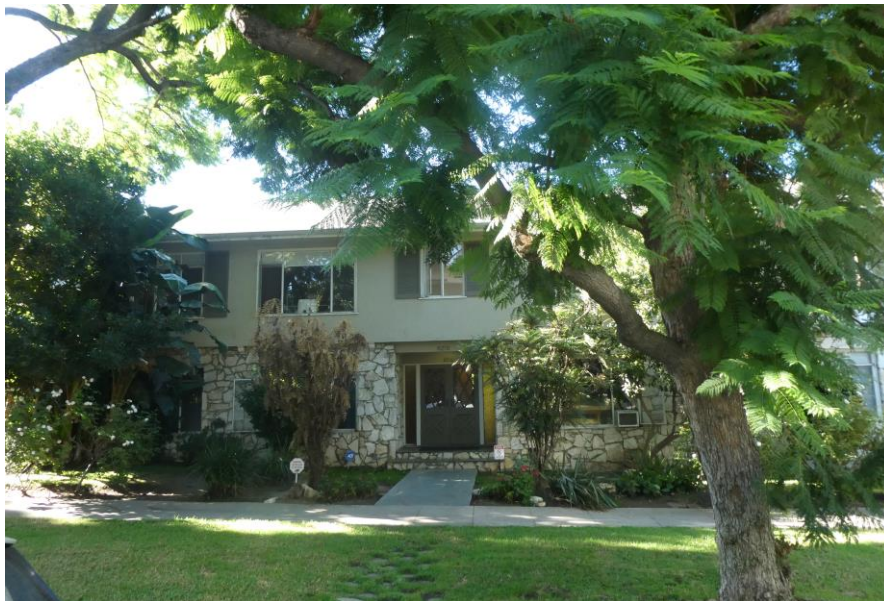
**P5a. Photograph or Drawing:** (Photograph required for buildings, structures, and objects.)

(View, date, accession #)  
View facing south, September 2022.

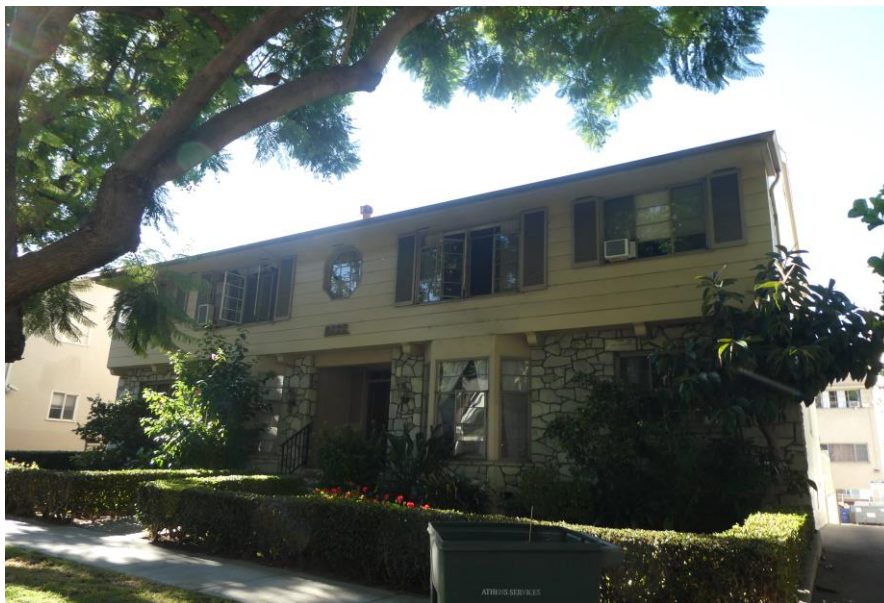
(View, date, accession #)  
View facing southeast, September 2022.

**P3a. Description:** (Describe resource and its major elements. Include design, materials, condition, alterations, size, setting, and boundaries.)  
This is a 2-story Postwar Courtyard Apartment with Mid-Century Modern influences built in 1953. The building is U-shaped in plan. Exterior walls are wood clapboard, stucco, and rock veneer. Ornamentation consists of wood window shutters. The building has a cross-gabled roof clad in composition shingles with boxed eaves. Fenestration consists of multi-light metal casement windows and a multi-light octagonal window. Individual units appear to be accessed by interior corridors. The main entrance to the building consists of a pair of wood-paneled doors. The entrance is accessed by a set of shallow steps.

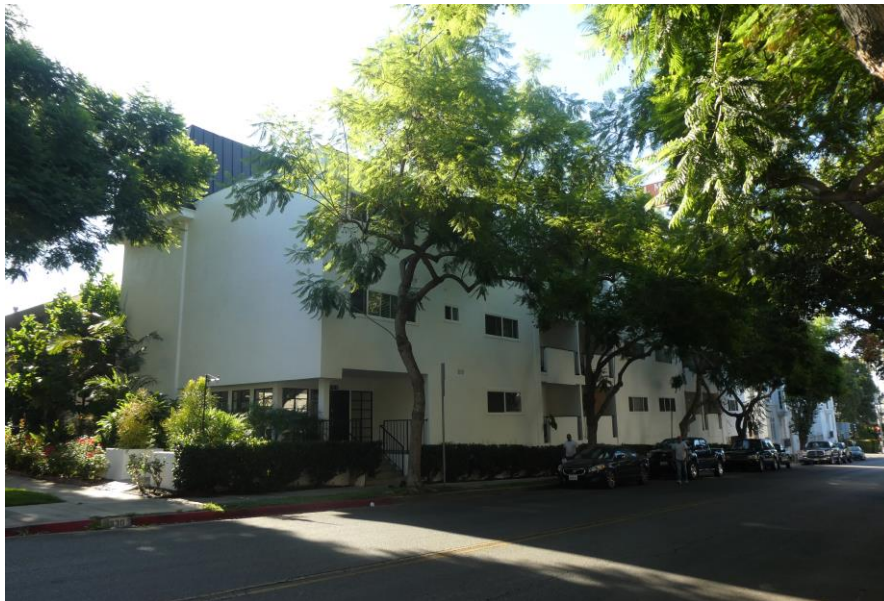
(View, date, accession #)  
View facing southeast, September 2022.

The building has a front yard area with a lawn, shrubs, and trees and foundation plantings along the street-facing elevations. There is a vehicular entrance on the west elevation along Sweetzer Avenue.

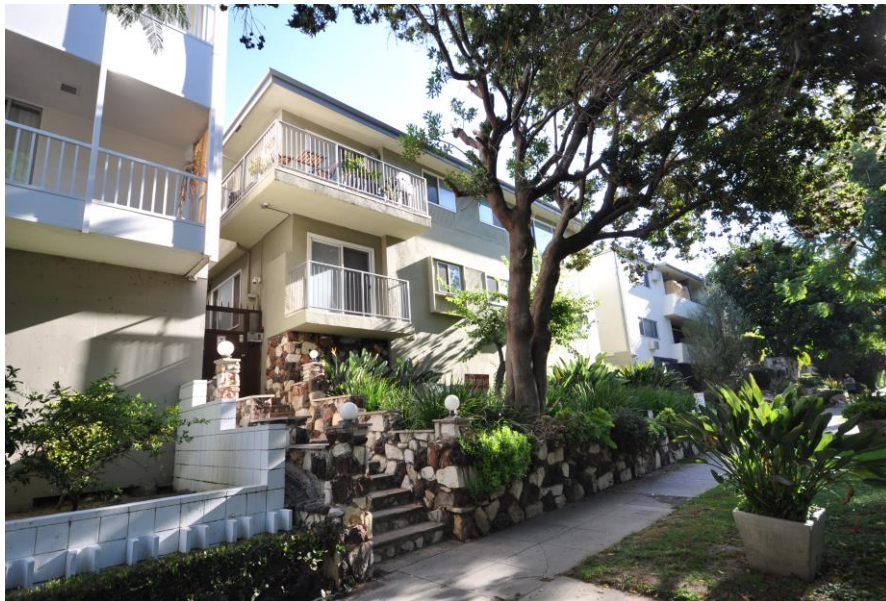
**P5a. Photograph or Drawing:** (Photograph required for buildings, structures, and objects.)

(View, date, accession #)  
View facing northeast, September 2022.

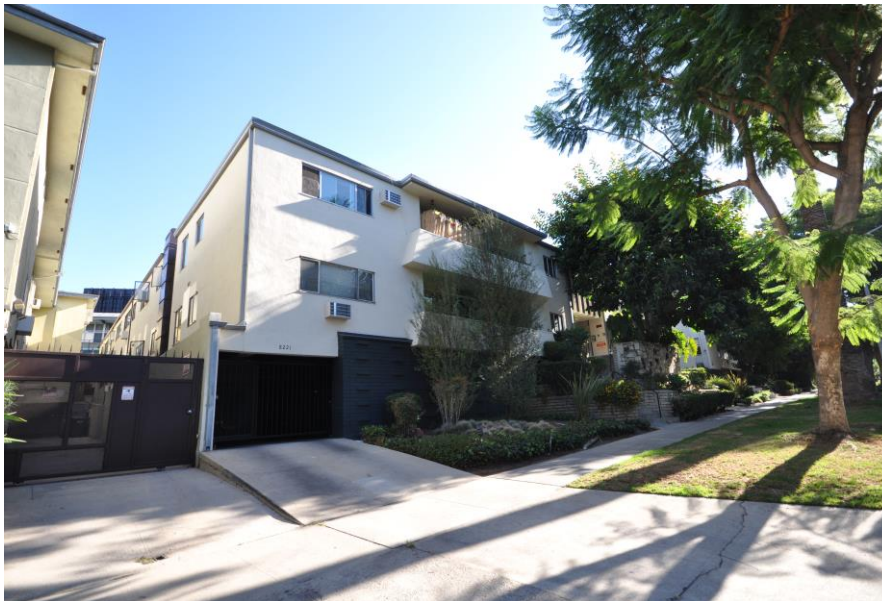
(View, date, accession #)  
View facing northeast, September 2022.

**P3a. Description:** (Describe resource and its major elements. Include design, materials, condition, alterations, size, setting, and boundaries.)  
This is a 2-story Postwar Courtyard Apartment built in 1956. The building is O-shaped in plan. Exterior walls are stucco and brick. The building has a flat roof with shallow eaves. Fenestration consists of single-light metal casement windows and vinyl sliding windows. Individual units are accessed by from the exterior surrounding the central courtyard. The main entrance is not fully visible due to vegetation but is accessed by two sets of mirrored concrete steps.

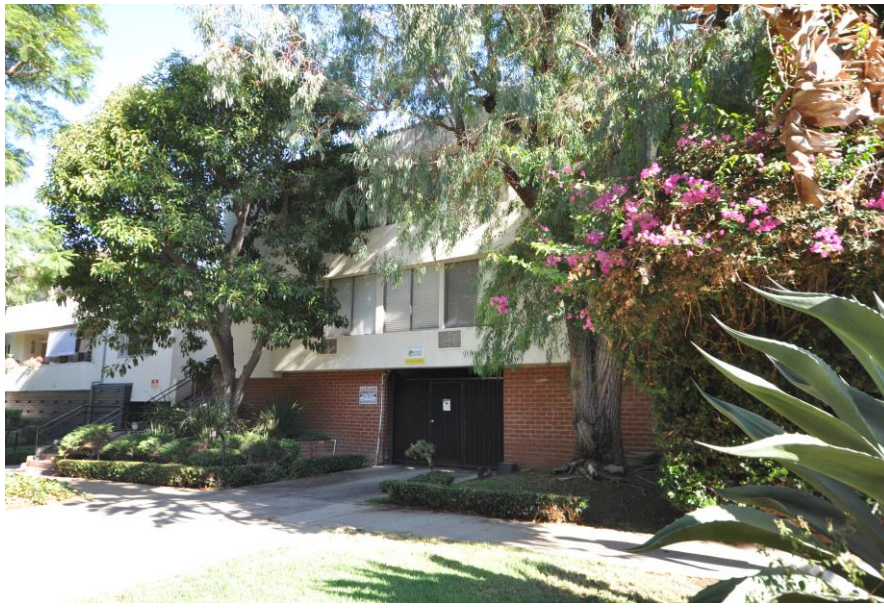
**P5a. Photograph or Drawing:** (Photograph required for buildings, structures, and objects.)

(View, date, accession #)  
View facing northwest, September 2022.

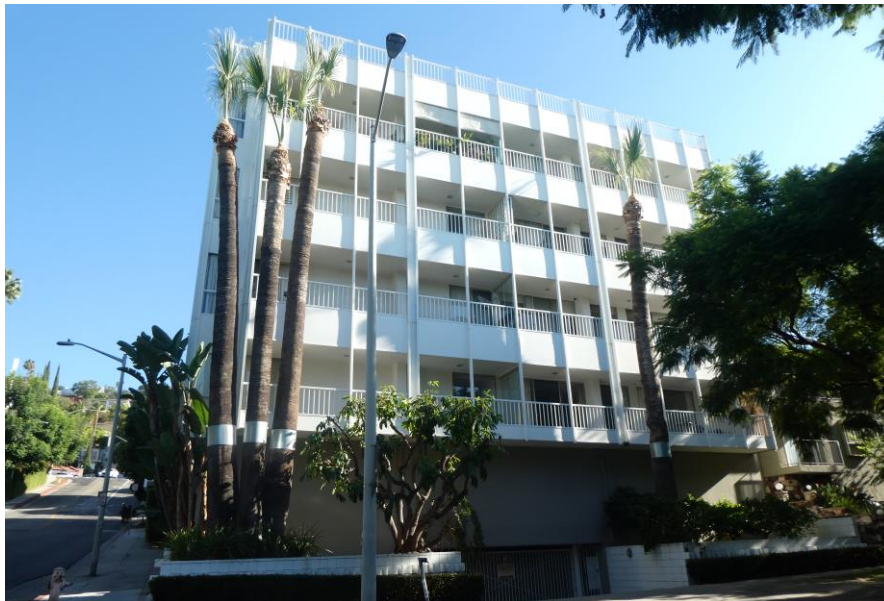
(View, date, accession #)  
View facing northeast, September 2022.

Landscaping consists of foundation plantings as well as trees and shrubs at the rear of the building. There is a vehicular entrance on the south elevation along De Longpre Avenue and another on the west elevation along Sweetzer Avenue.

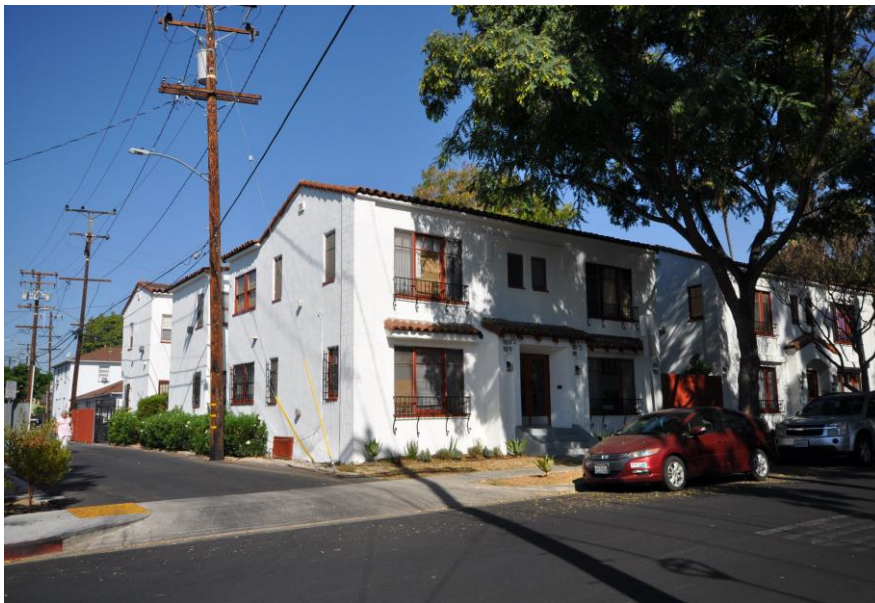
(View, date, accession #)  
View facing northwest. September 2022.

This is a 2-story Pre-War Apartment House (Type A) in the Spanish Colonial Revival style built in 1929. The building is irregular in plan. Exterior walls are stucco with a hand-troweled texture. Ornamentation consists of ashlar scored stucco and wrought iron balconettes. The building has a cross-gabled roof lined with clay tile along the edges and gable ridge. Windows include single- and multi-light fixed, casement, and double-hung wood windows and vinyl replacements in original openings. The main entrance is a pair of French doors at the center of the front elevation, sheltered with a shallow clay tile overhang and accessed by a set of concrete steps. Individual units are accessed via interior corridors. Landscaping is limited to a front lawn area and foundation plants along the front and side of the building. There is surface parking to the rear of the property. A wood dog-ear fence and gate connects the front elevations of 1109 N. Vista and 1115 N. Vista.

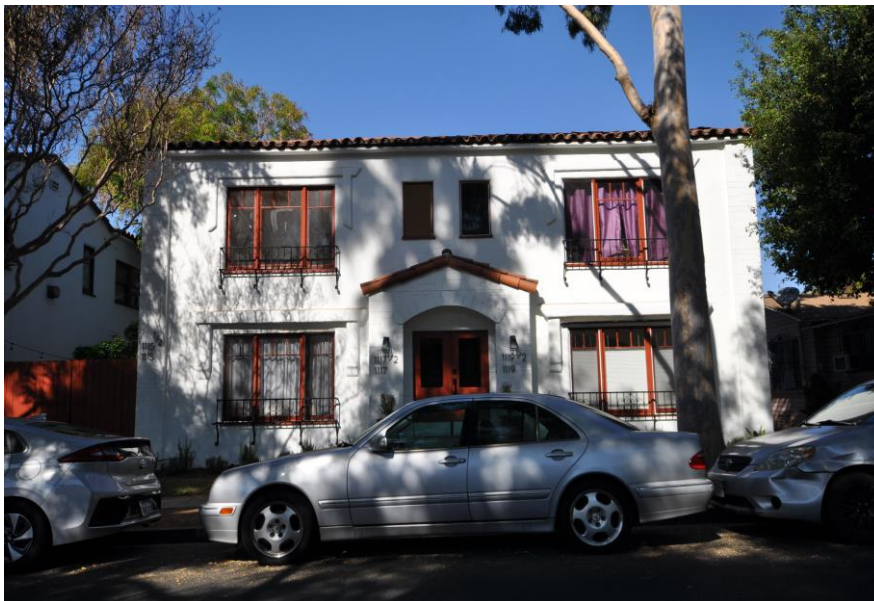
(View, date, accession #)  
View facing west. September 2022.

This is a 2-story Pre-War Apartment House (Type A) in the Spanish Colonial Revival style built in 1929. The building is irregular in plan. Exterior walls are stucco with a hand-troweled texture. Ornamentation consists of ashlar scored stucco and wrought iron balconettes. The building has a cross-gabled roof lined with clay tile along the edges and gable ridge. Windows include single- and multi-light fixed, casement, and double-hung wood windows and vinyl replacements in original openings. The main entrance is a pair of partially glazed wood doors recessed within a shallow, gabled projection and accessed by a set of concrete steps. Individual units are accessed via interior corridors. Landscaping is limited to a front lawn area and foundation plants along the front and side of the building. There is surface parking to the rear of the property. A wood dog-ear fence and gate connects the front elevations of 1109 N. Vista and 1115 N. Vista.

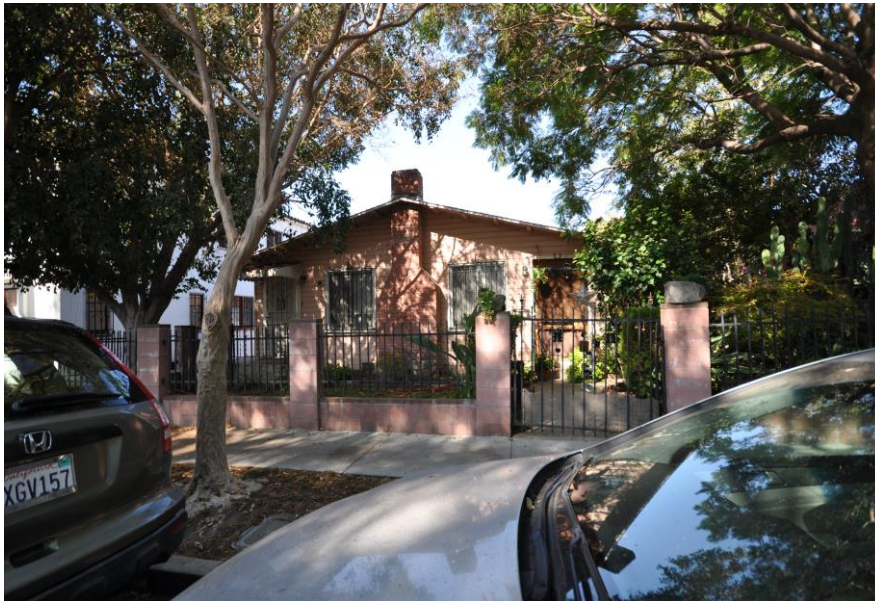
**P5a. Photograph or Drawing:** (Photograph required for buildings, structures, and objects.)

(View, date, accession #)  
View facing west. September 2022.

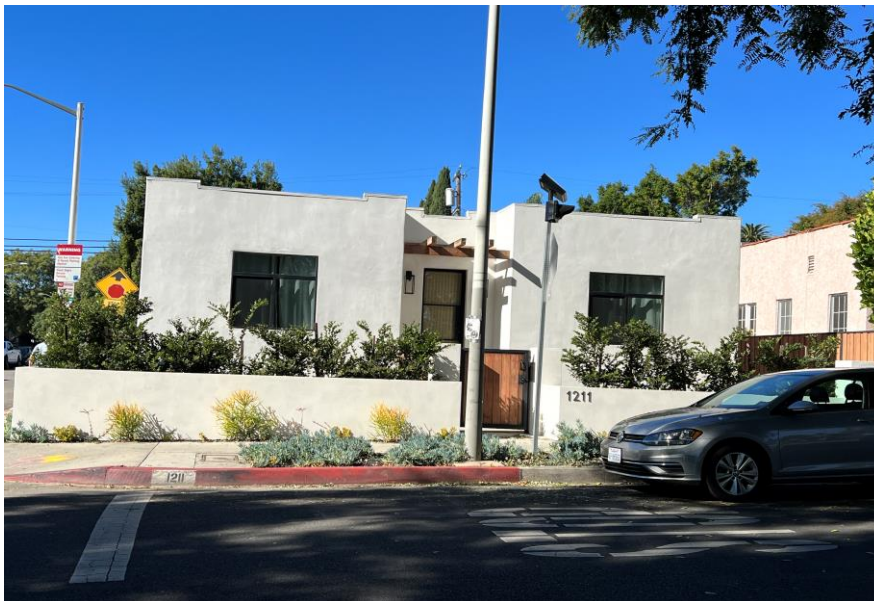
This is a 1-story single-family residence in the style built in 1923. Research indicates that it was originally a duplex and had two units through at least 1962. The building is rectangular in plan. Exterior walls are stucco. Ornamentation includes a wood trellis over the main entrance. The building has a flat roof with raised parapet. Windows are fixed, sliding, and hung vinyl. The entrance is located at the center of the primary elevation and consists of a fully glazed three-light metal door. Landscaping includes shrubs and foundation plantings. The front of the property is partially enclosed by a low stucco wall, and there is a concrete side driveway that runs along the north edge of the property. There is a detached, 1-story ancillary building at the rear of the property. The year of construction is not indicated in the assessor's records, but it is shown on the 1950 Sanborn Map as a garage.

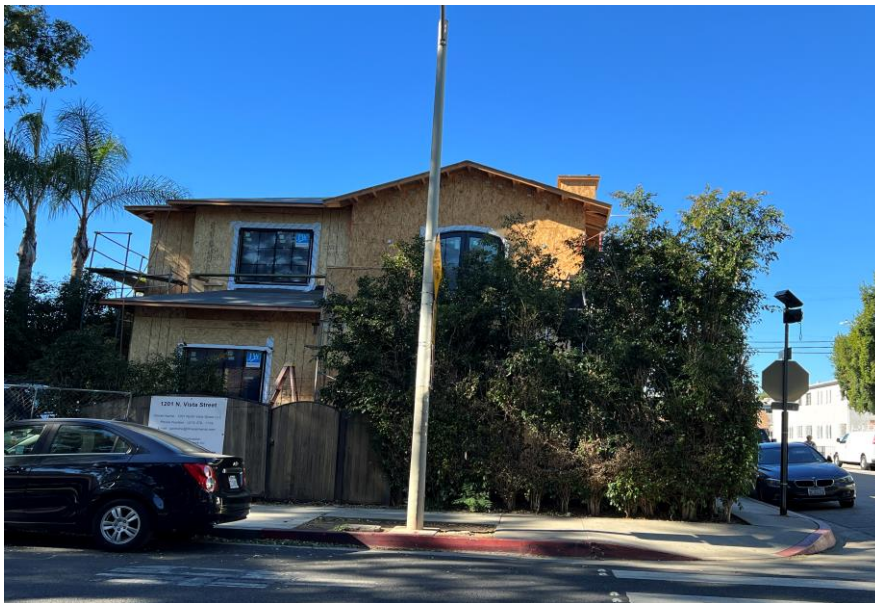
This property was previously improved with a 1-story Duplex in the Spanish Colonial Revival style built in 1923. It was demolished c. 2022 and is being replaced with 2-story new construction.
